**HEAVY LIFT HELICOPTER - CARGO HANDLING ATC PROGRAM**

**VOLUME III - Results of Tests, Inspections, and Evaluations**

Boeing Vertol Company  
A Division of the Boeing Company  
Philadelphia, Pa. 19142

October 1976

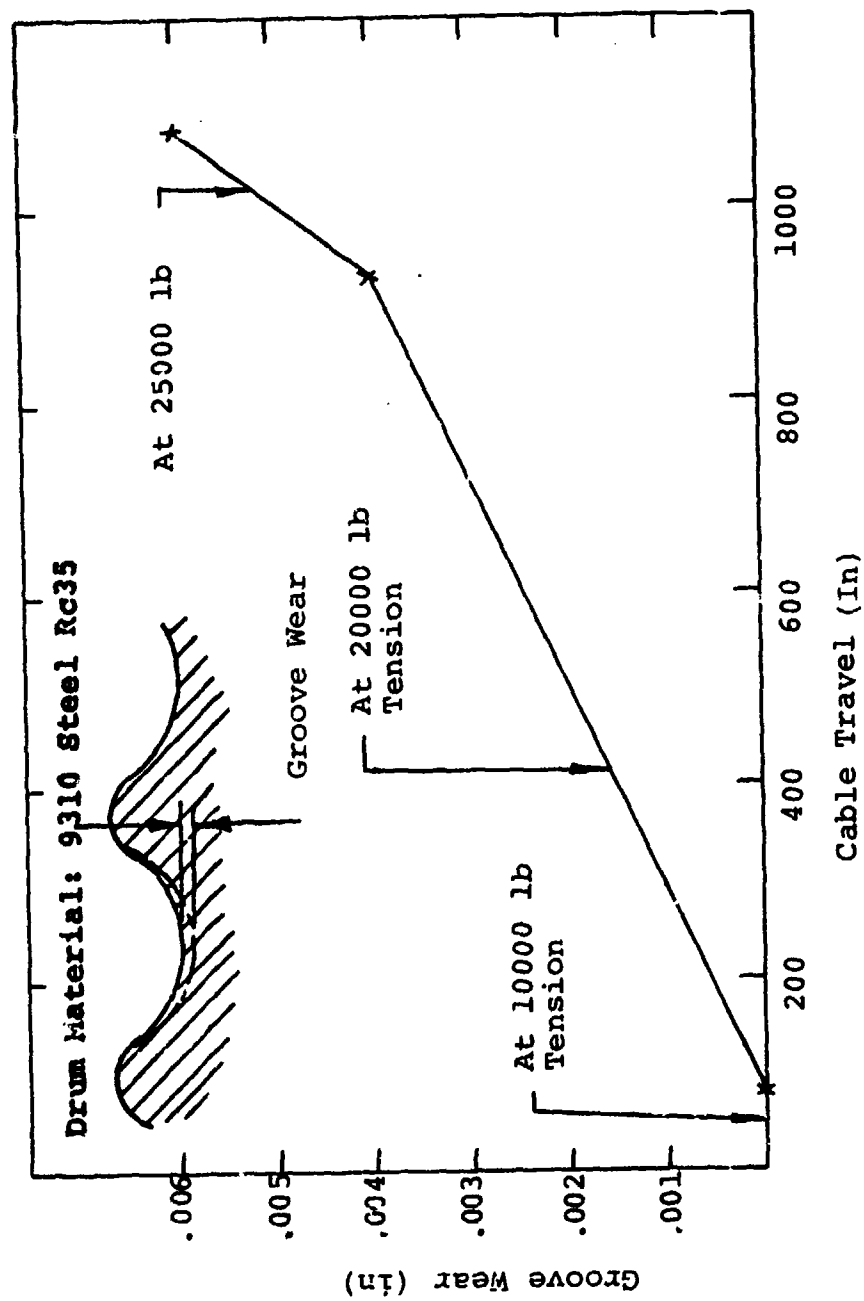
Figure 3. Drum Groove Wear Rate.

The test resulted in a wear rate as shown on Figure 3. The rate of wear was maximum at the highest load, as expected, due not only to the high load, but also to the trapping of drum particles between the cable strands. This condition would be less severe in normal service since a normal hoisting operation would cause some or all of these particles to fall out.

The test indicated a maximum drum wear of .006 inches under the severe test criteria. This magnitude of wear will not affect the operation of the drum and was therefore acceptable. No significant wear to the cable was found.

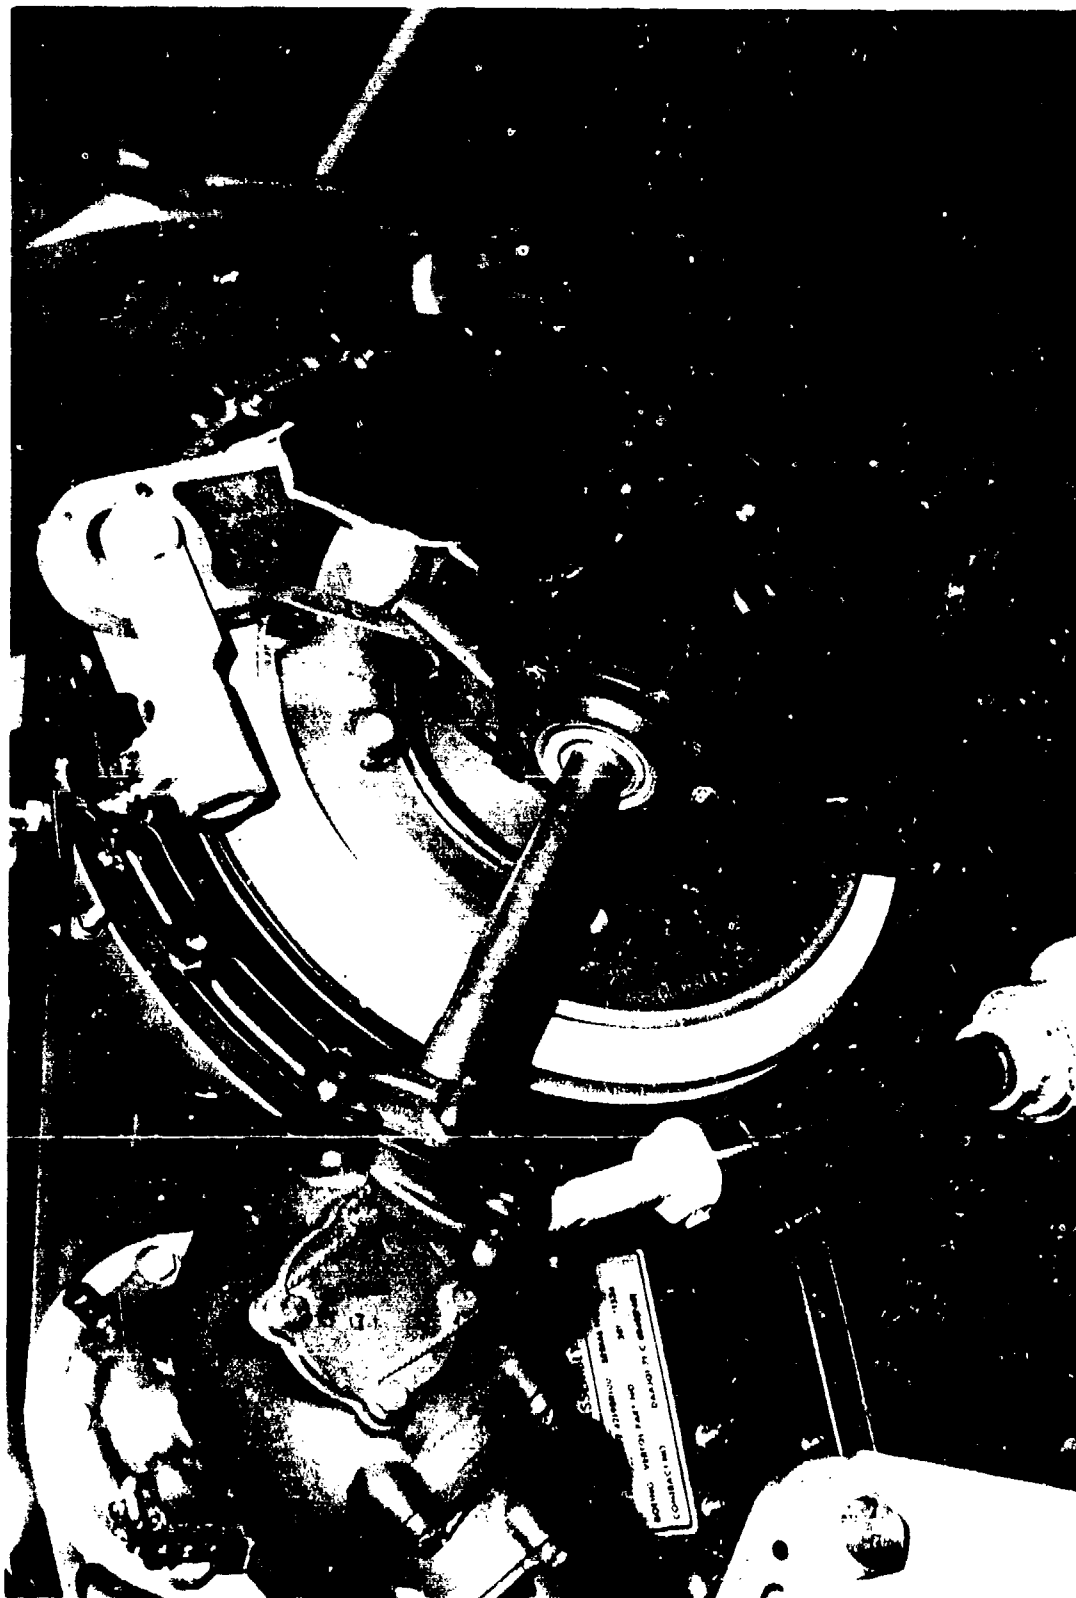
Using both charges in the cable cutter caused the cutter housing outside the anvil area to become distorted. This condition prevented the removal of the cutter assembly from the carriage assembly. A small amount of filing was required in the raised areas of the cutter housing in order to remove the cutter assembly. The blade penetrated the anvil approximately  $3/8$  inch. The hoist was operated to remove the cable.

Figure 12. Damage to Hoist and Load Isolator after Cable Cutting Test.

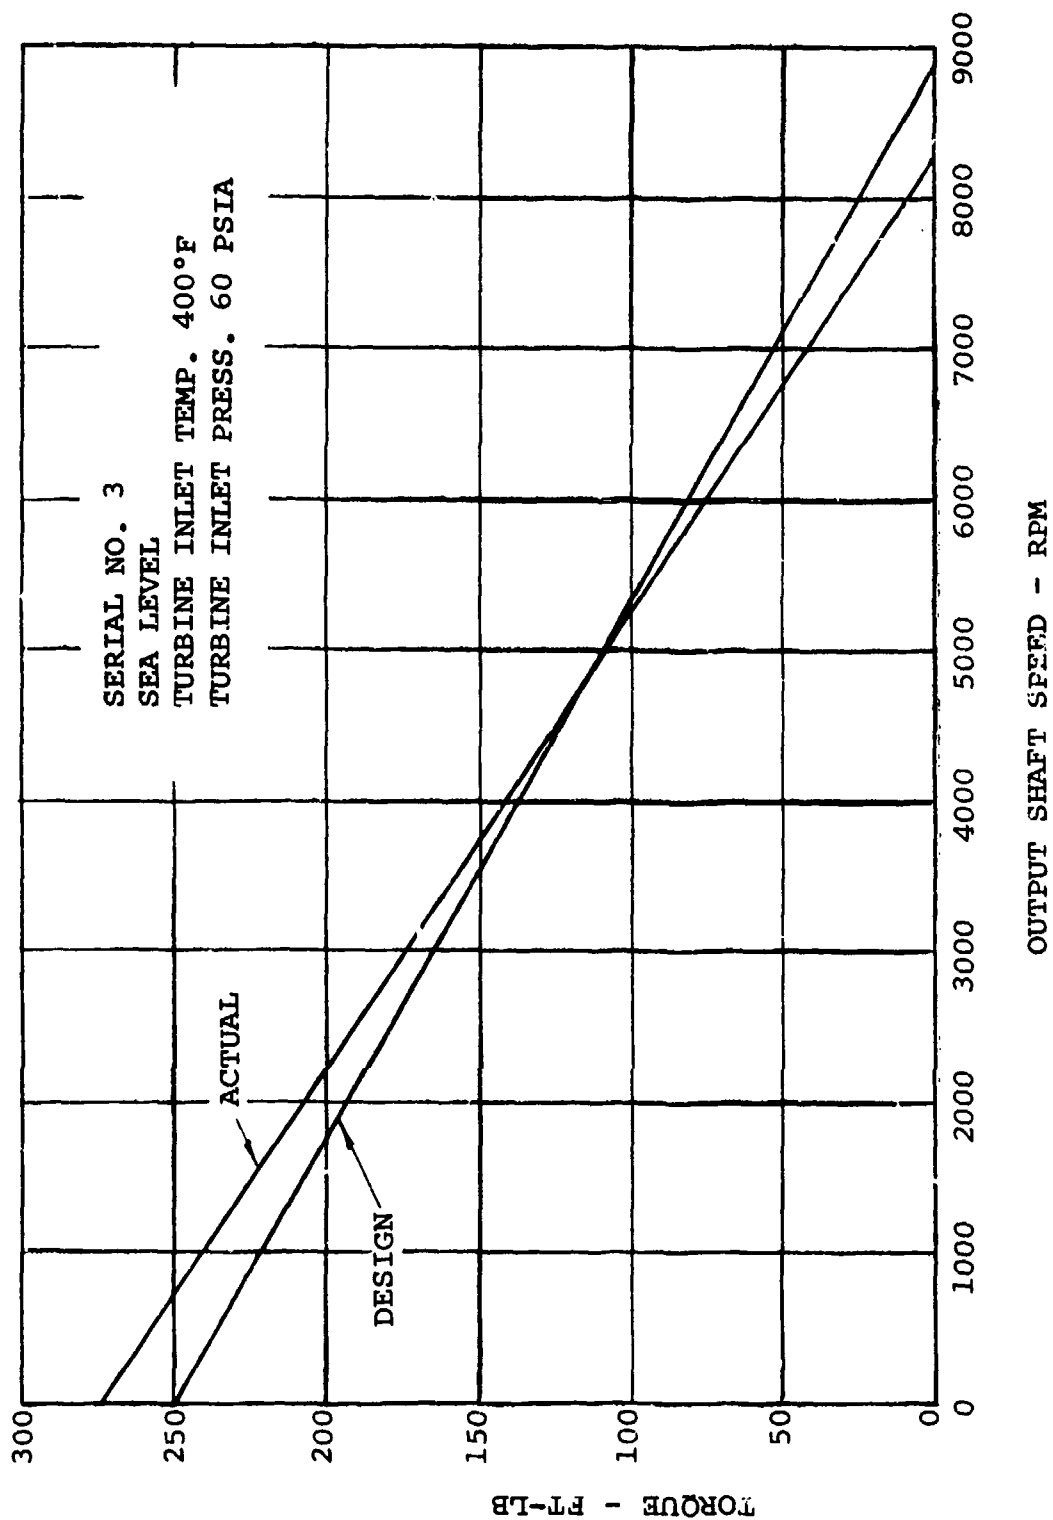
The redesigned hoisting and reversing turbines were tested in air turbine motor serial number 3. The actual performance is shown in Figure 49.

Figure 49. Redesigned ATM Turbine Performance, Torque vs Speed.

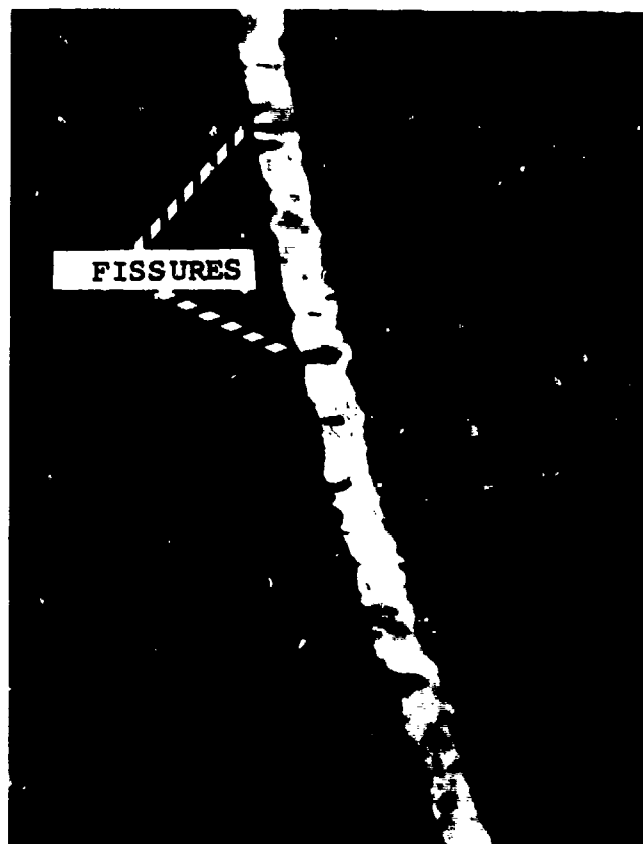
In the second draw, with zinc applied over the nickel-boron coating, the zinc was worked into the fissures in the nickel-boron coating by the first few dies but was peeled off the wire completely by the sixth die. These conditions are illustrated in Figure 76. Post-drawing corrosion tests of samples taken after each die were unsatisfactory.

Figure 74. 400X-Photomicrograph - Fissures in .4 mil Nickel-Boron Coating on .105-in Carbon Steel Wire after Drawing to .0345 in-dia.

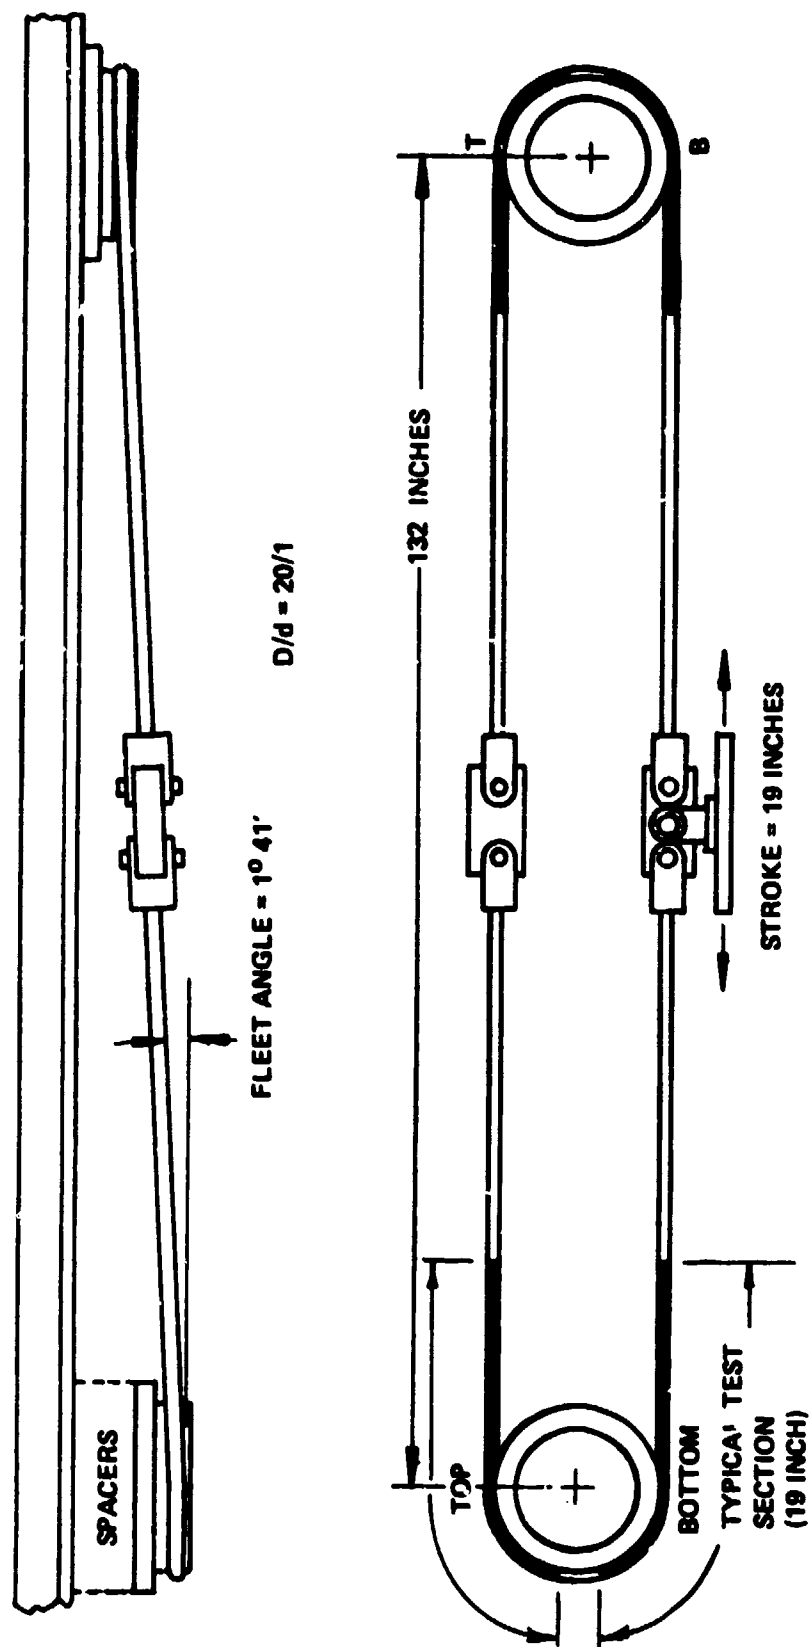
The electro-galvanized 36x7 cable samples demonstrated that they were superior to all other configurations tested. This result is based on the total number of external and internal wires broken in the cable samples as a result of the 10,800 simulated hoisting cycles. External wire breakage was apparent during and after the test. Internal failures were determined by examination of the cable test sections. On this basis, the cable configurations tested were ranked in the order of fatigue resistance, with number one being the best:

Figure 92. Layout of Bend-Over-Drum Fatigue Machine  
With a typical cable specimen.

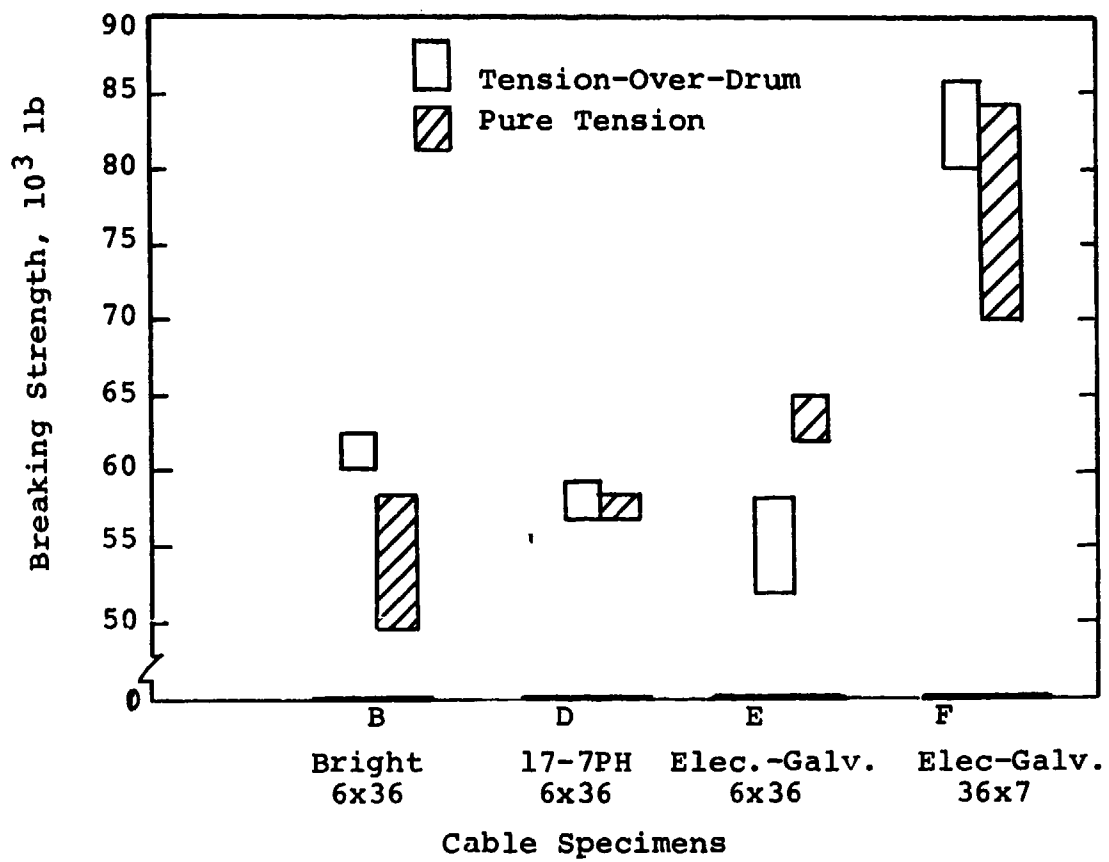
These tests were conducted with four cable configurations, the 18-2 Mn having been eliminated. In the case of the 17-7 PH, 6x36 cable, failures occurred in the area of the drum groove and this cable demonstrated the smallest variation in the breaking load of the four cable types. In the cases of the galvanized 36x7, the bright and galvanized 6x36 cables, all failures were at one of the sockets with a greater variability in load than shown in the 17-7 PH cable, although within the range of previous pure tension tests. The 36x7 cable again demonstrated significant tensile strength superiority. See Figure 98 for the comparison of the failing loads in pure tensile (straight pull) tests, versus tension over drum tensile strength tests.

Figure 98. Breaking Strengths, Pure Tension and Tension-Over-Drum Tests.

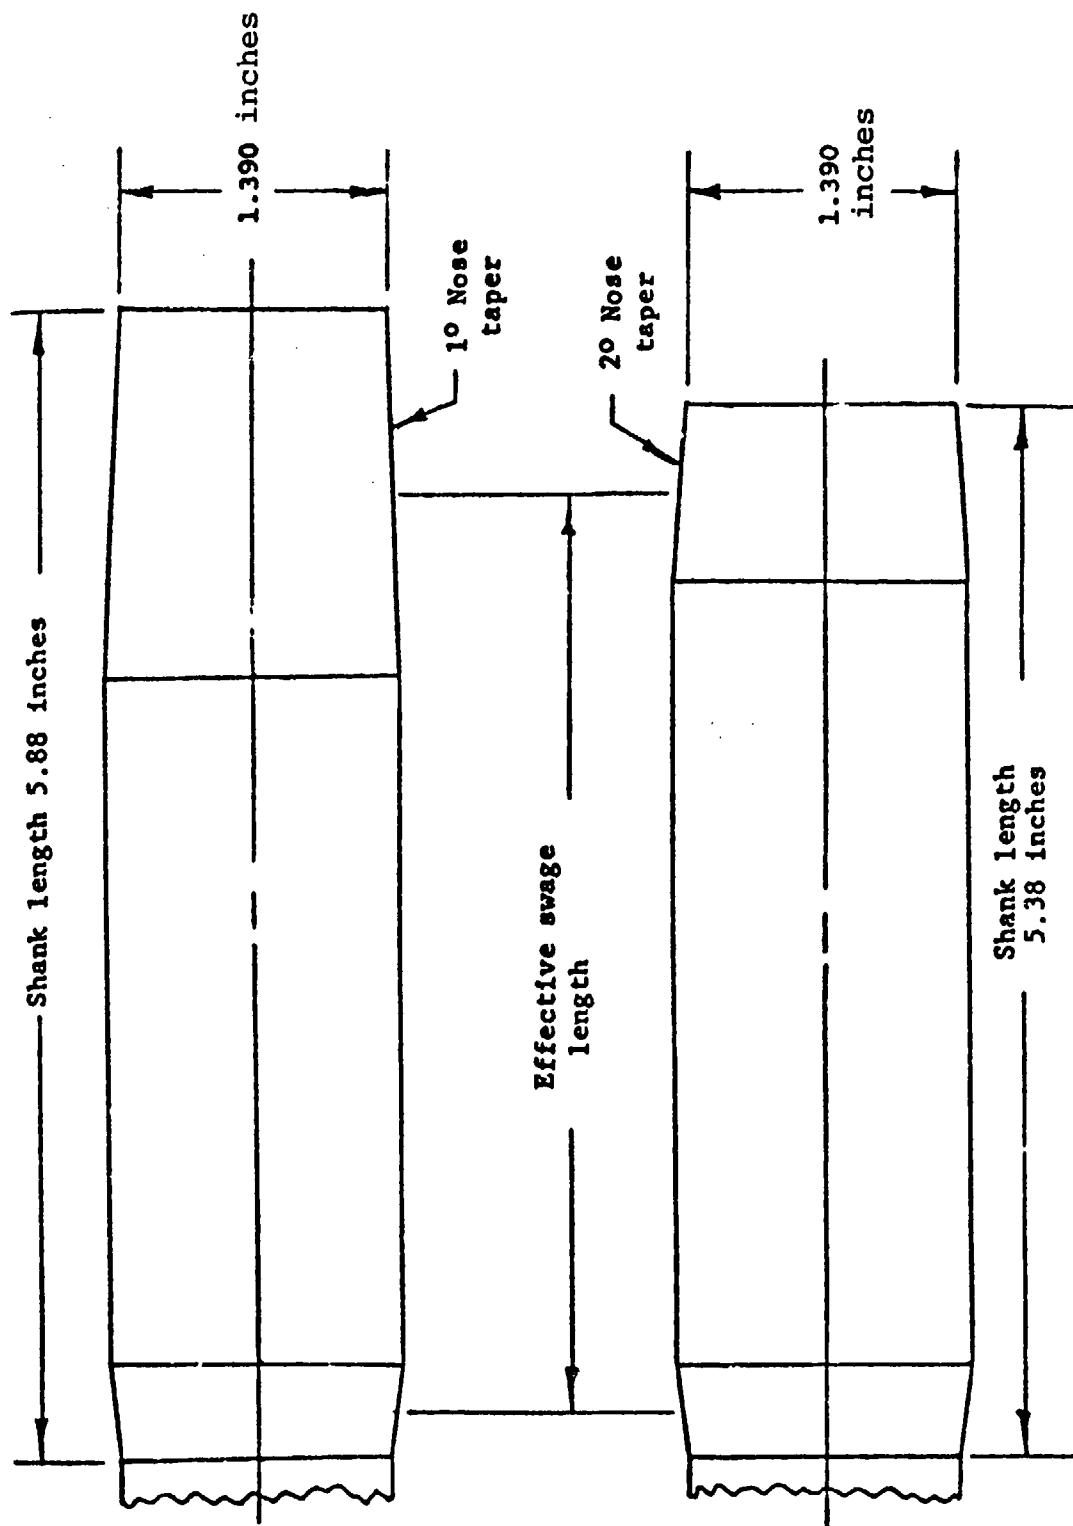
Figure 101. Shank Geometries Showing How Change in Nose Taper Allowed for Shorter Shank Length While Maintaining the Same Effective Swage Length.

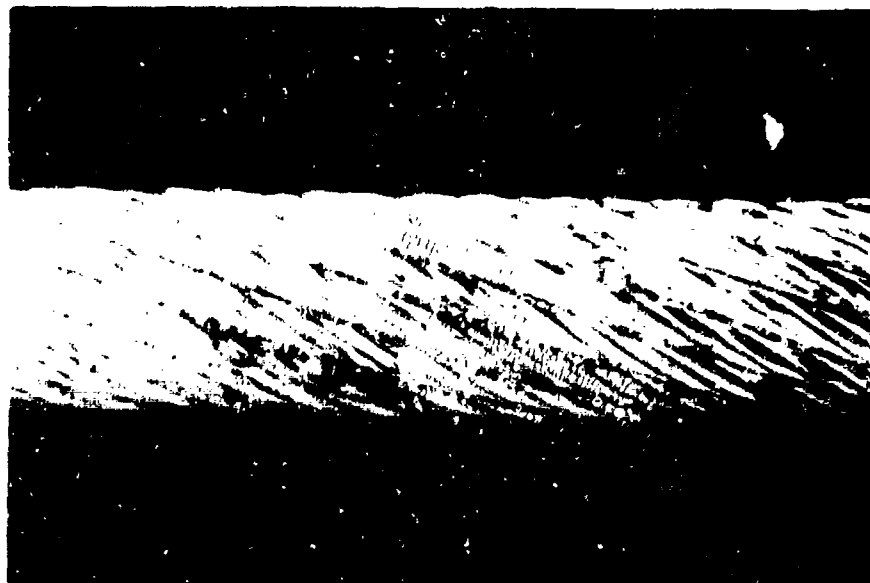
Figure 146. Cable Lubricant Migration After 5400 Load Cycles. (Cable was cleaned after 4320 cycles.)

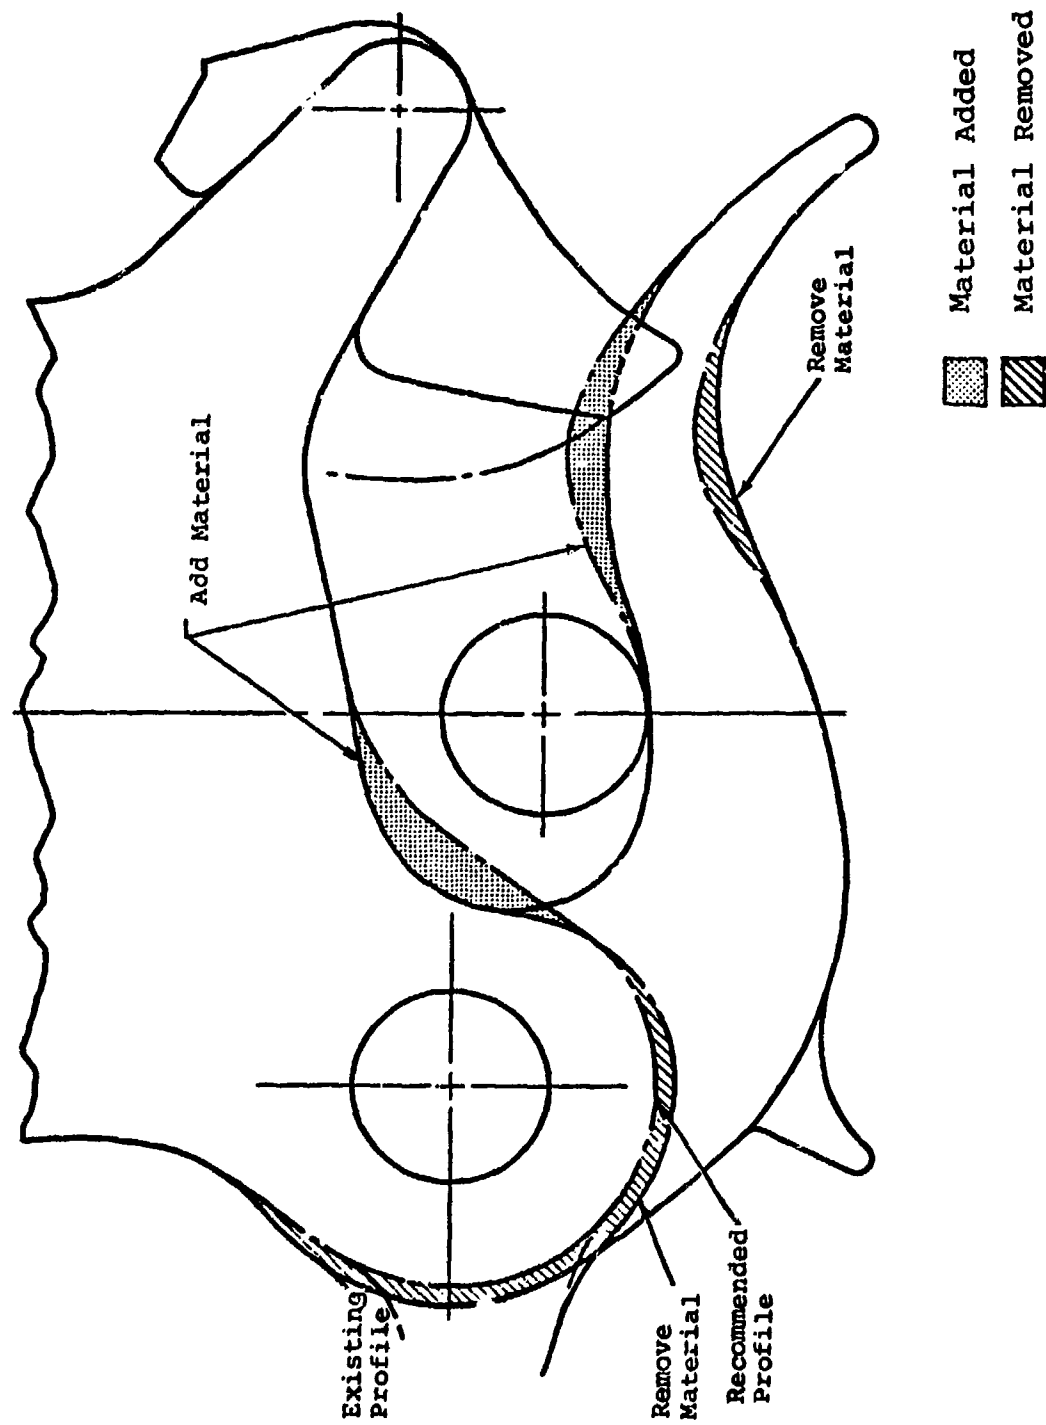
Figure 156. Coupling Modifications.

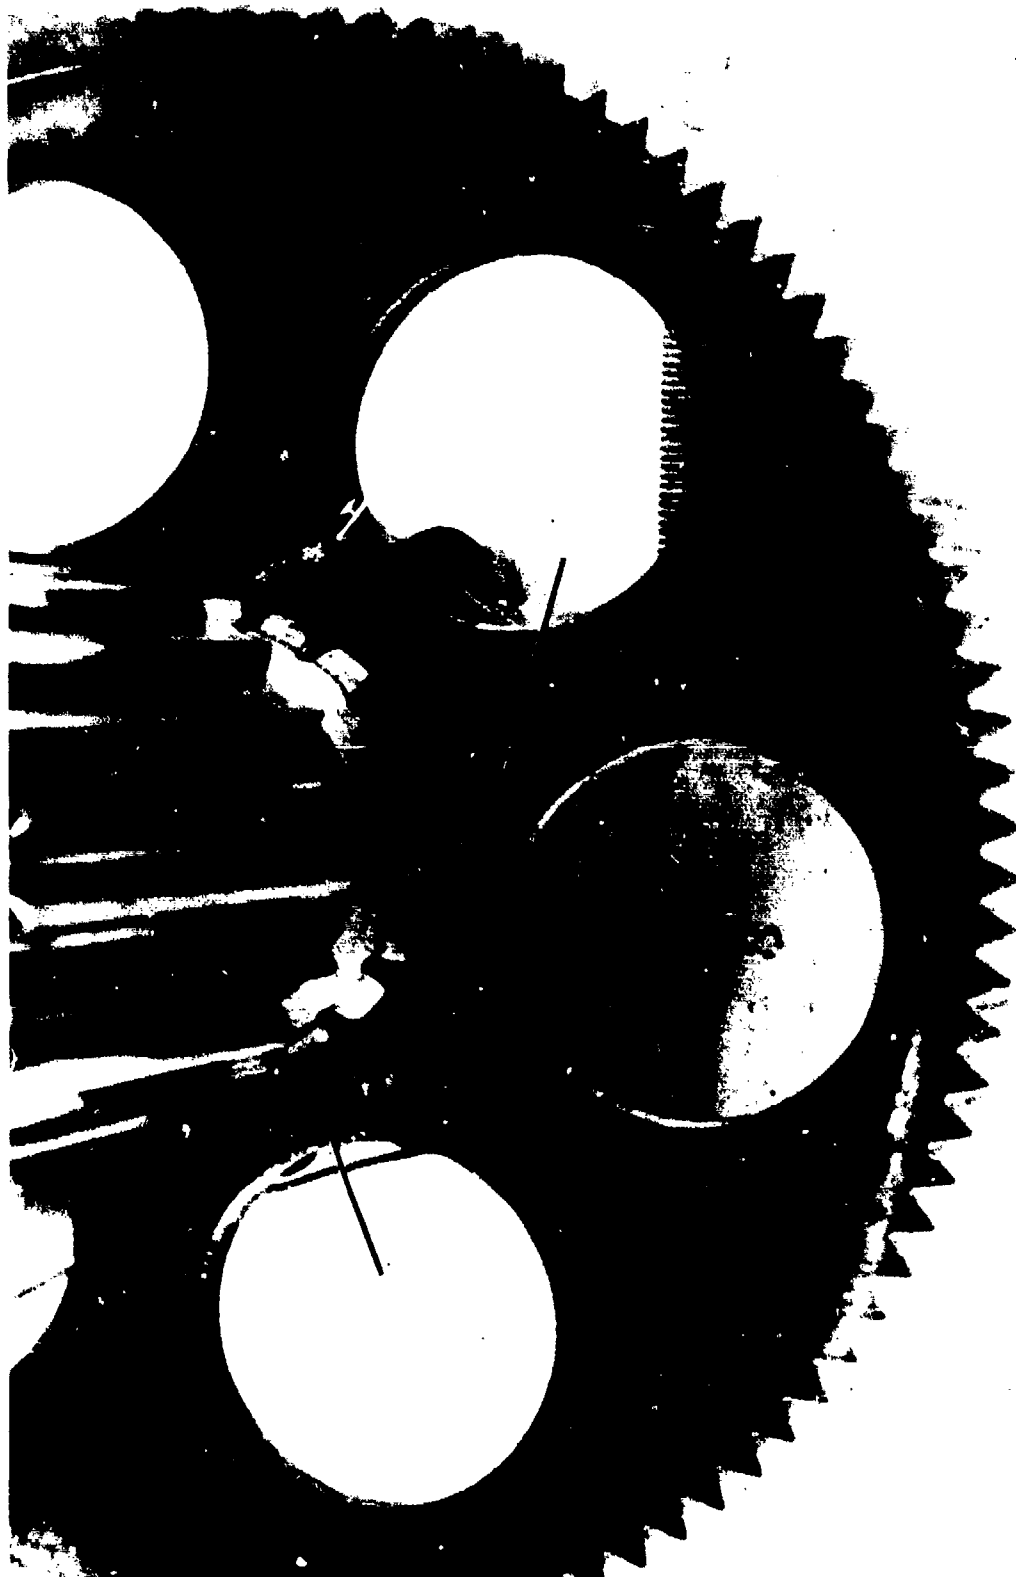
Figure 174. Two Cracks Radiating From Electron Beam Weld  
From Shaft to Lightening Hole.
